Reductions in environmental noise emissions from Dublin's light rail system following a rail grinding campaign on embedded track

Stephen Byrne

Transport Infrastructure Ireland, Republic of Ireland.

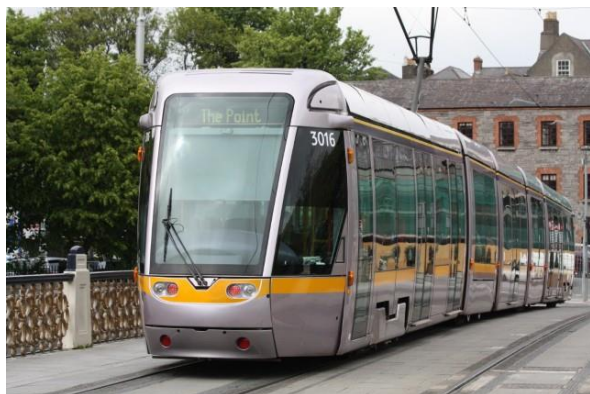
Photograph 1: Luas tram on embedded track

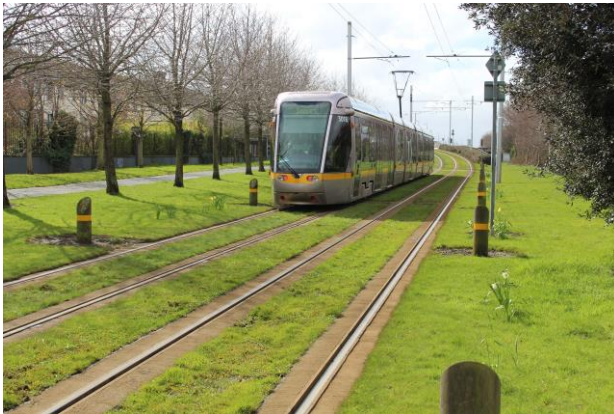
Photograph 2: Tram on embedded (grass) track

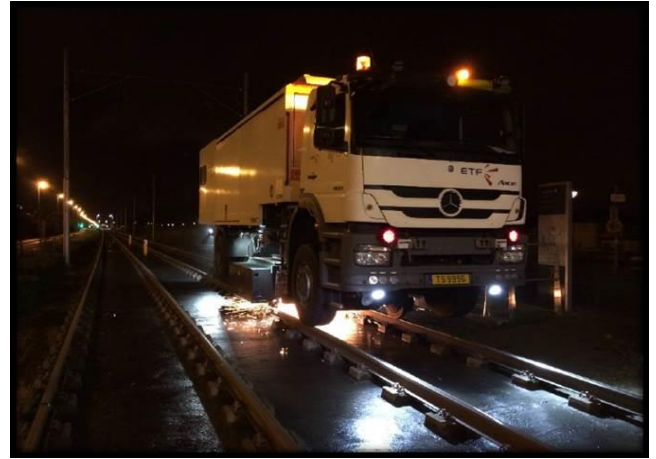
Photograph 3: Rail grinder on slab track

A grinder, fitted with six grinding stones, was used for the grinding programme. Results of the pre-grinding corrugation survey were reviewed and locations identified requiring treatment. The number of passes ranged from 2–16. Both Location 7 and Location 8 were ground as part of the May 2016 campaign.
