# Analysis of a maxima position estimator on acoustic images of a fan matrix for failure detection

#### Summary

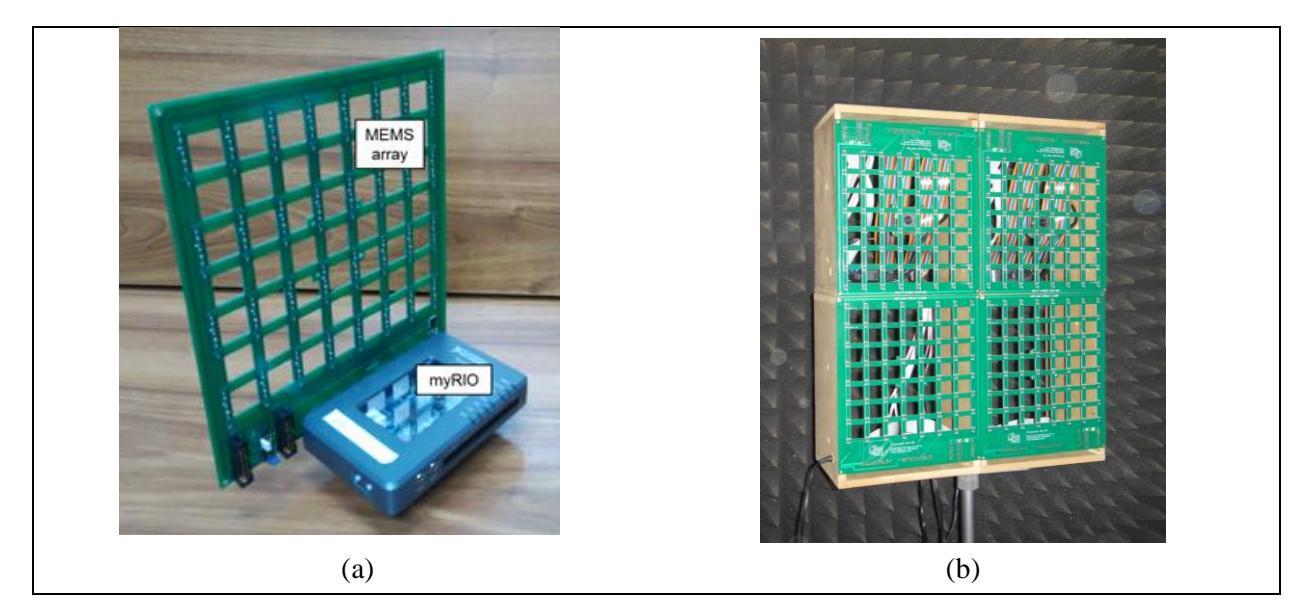
Figure 1. (a) Array module with myRIO and MEMS array board. (b) 16x16 array.

This section shows the acquisition and processing system used in this work [9], based on a 2D array of MEMS microphones. The acoustic images acquisition system used in this paper is based on 4 Uniform Planar Arrays (UPA) of 8x8 2.125cmuniformly-spaced MEMS microphones, forming a bigger UPA of 16x16 sensors. This 8x8 array module and the 16x16 array are shown in Figure 1. The system implements the acquisition of the acoustic signals, using the MEMS array, and then the acquired signals are processed in order to generate the acoustic images, using wideband beamforming; as it is shown in Figure 2. The programming language used is NI LabVIEW 2017, along with its Real Time, FPGA, and GPU modules, which allows developing applications on different hardware platforms like those used in the system: FPGA, Embedded Processor (EP), PC, and GPU.

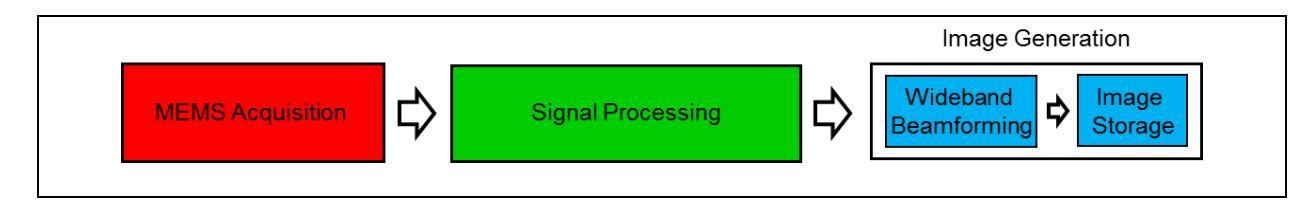
Figure 2. Software algorithms diagram.

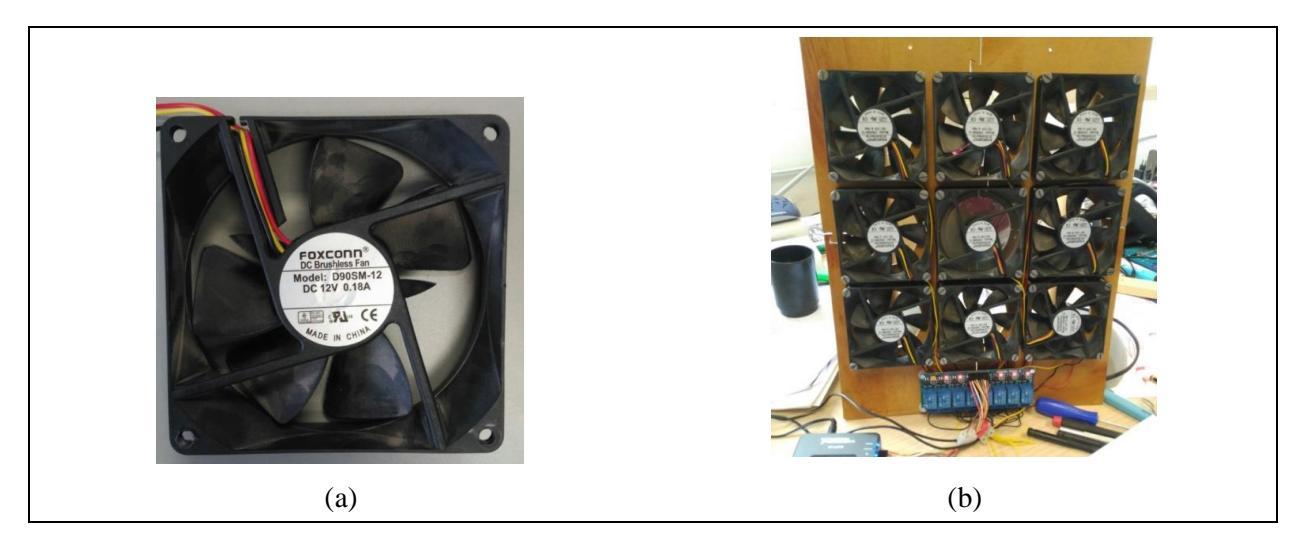
Figure 3. (a) Foxconn D90SM- 12 fan. (b) Fan matrix built for the test.

This study case is focused on obtaining acoustic images of a 3x3 fan matrix, specifically built to these tests with 9 coherent axial PC fans, which move the air in the direction of the fan axis. Each of the fans used to build the fan matrix is a Foxconn D90SM- 12 3-Pin with 7 blades. One of these fans is shown in Figure 3 (a), and Figure 3 (b) shows the fan matrix implemented for the tests. As it can be observed in Figure 3 (b), the fans of the matrix are controlled by a relay interface board that allows turning them on and off independently, in order to create different situations of faulty fans in fault diagnosis tests.

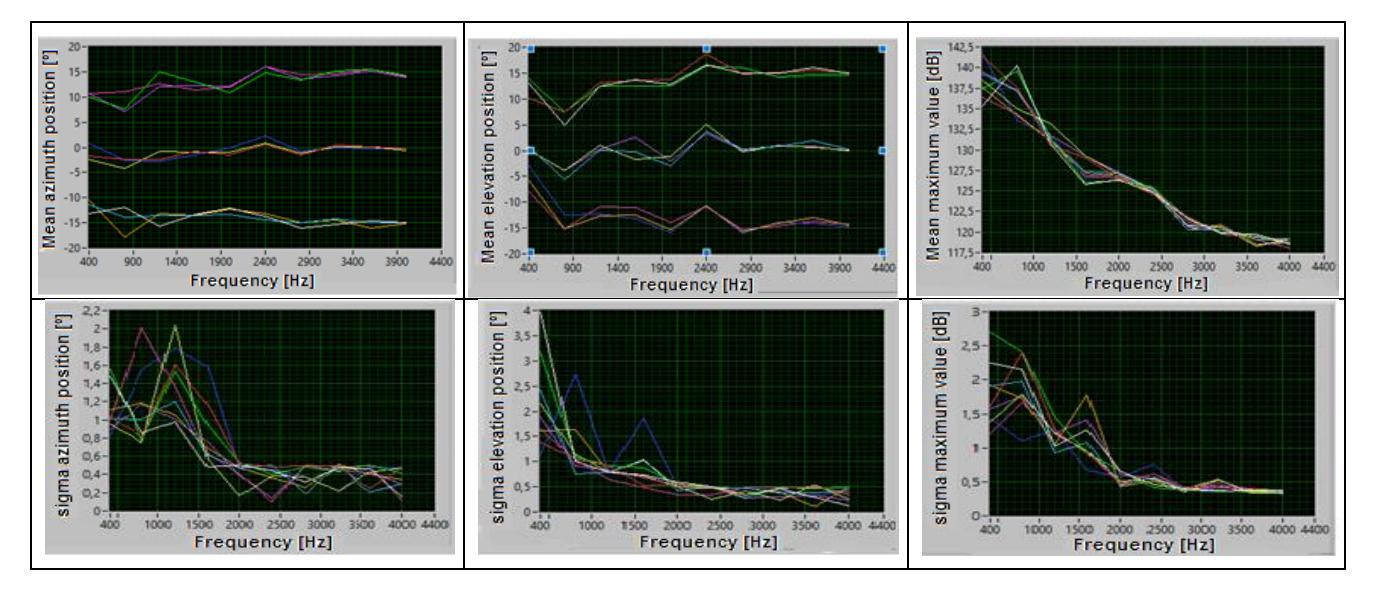
Figure 4. First scenario: only one fan is running. First column: Mean maximum position and value vs. frequency. Second column: Standard deviation of maximum position and value.

Figure 4 shows, for this first scenario (only one fan of the matrix is running), the mean (first row) and standard deviation (second row) values for the position coordinates (first and second columns) and the specific value (third column) of the maximum of the acoustic image obtained for the selected working frequencies (400 Hz and its multiples, until 3600 kHz). In this figure 4, each coloured line represents a working situation of the system in this defined scenario. Each line matches with the corresponding working fan on the matrix.

In the first and second columns of Figure 4, it can be observed that for all the working frequencies, the mean value of the azimuth and elevation coordinates are nearly constant for the nine different working situations. For working frequencies lower than 2000 Hz, the standard deviations of the azimuth and elevation coordinates are high (until 2° and 4°). This could be a problem for the estimator. For higher working frequencies, the standard deviation values are low  $(0.4^{\circ})$ , corresponding with a better behaviour of the estimator. In the first column of Figure 4, the three azimuth values corresponds with the real position of each column of the fan matrix. In the second column of Figure 4, the three elevation values corresonds with the real position of each row of the fan matrix.

In the third column of Figure 4, it can be observed that the maximum value decreases with the increasing frequency. It can also be observed that for the all nine working situations, the maximum values are very similar. As in the images corresponding with the maximum position coordinates, for working frequencies lower than 2000 Hz, the standard deviations of the maximum values are high (until 1.4dB), and for higher working frequencies, the standard deviation values are low (0.4dB). It seems that in the first scenario, the maximum value is not a good parameter to be used to differentiate between the nine working fans of the matrix.

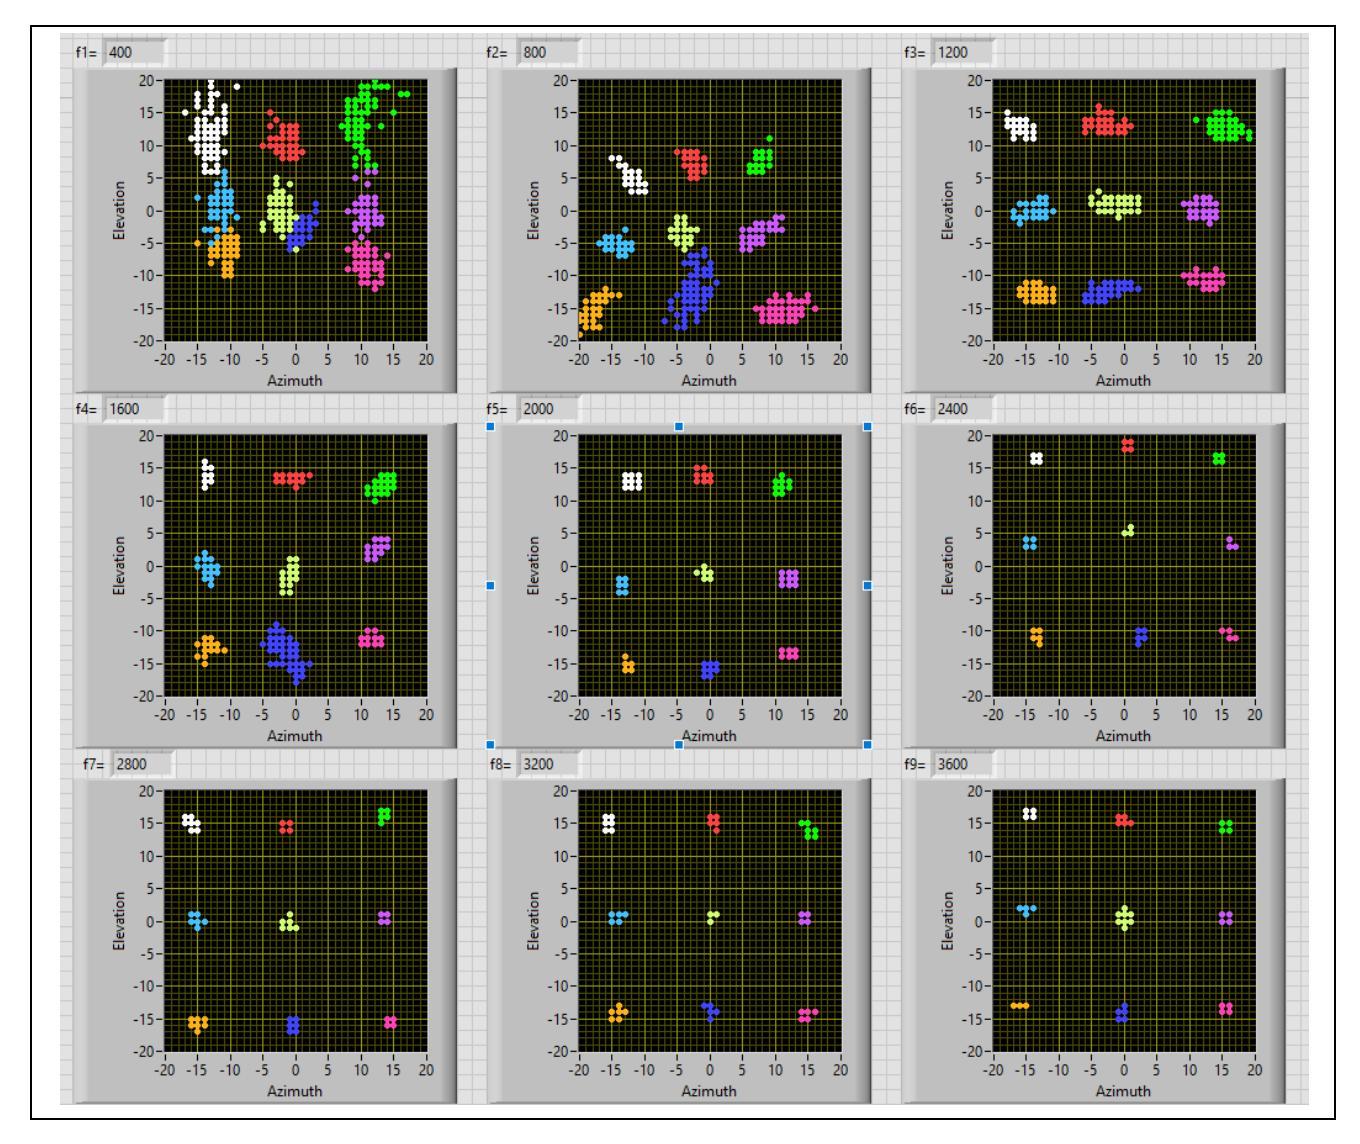
Figure 5. Maximum position dispersion vs. frequency for the first scenario (only one fan of the matrix is running).

Figure 5 shows, for the first scenario, the maximum position dispersion for the different working frequencies. In this figure, each coloured point represents the maximum position of one of the 100 acoustic images obtained for each working situation, i. e. for each working fan. It can be

observed that the dispersion decreases with the increasing frequency. It seems that for all the frequencies, the estimator could differentiate which fan is working in each situation. For the two first frequencies (400 and 800 Hz), the position of the working fans are displaced; for 400 Hz, the fan positions are moved above, and for 800 Hz, the positions are moved below to the right.

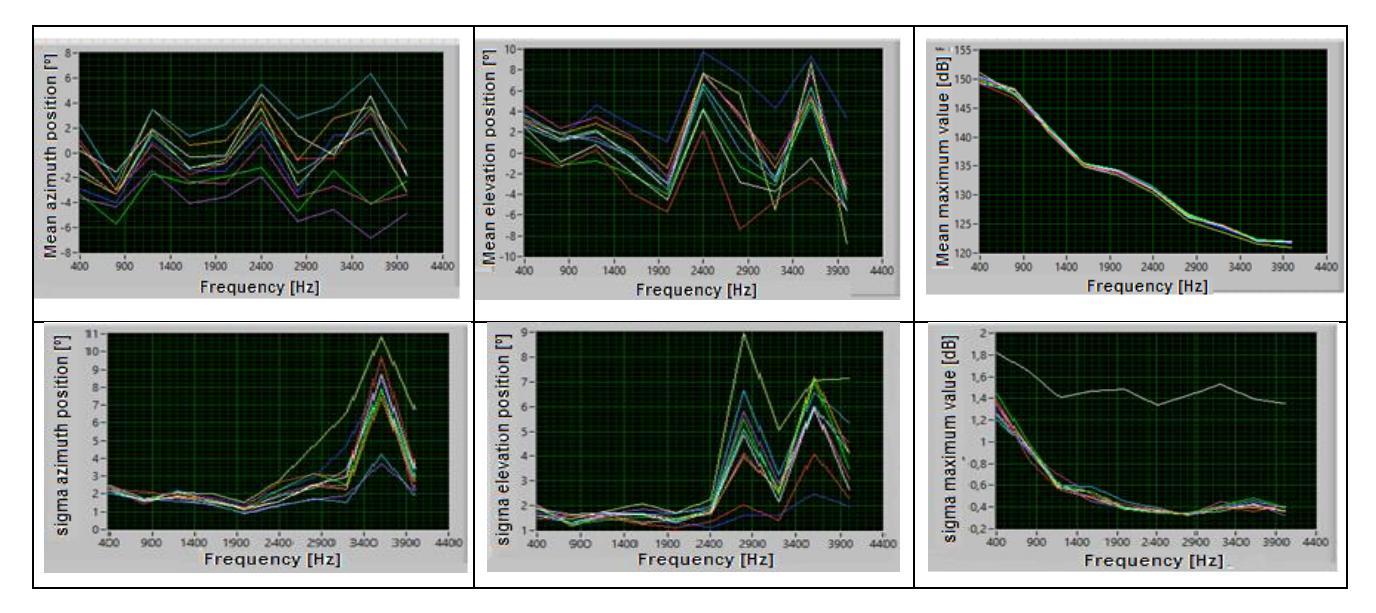
Figure 6. Second scenario: all the fans, except one, are running. First column: Mean maximum position and value vs. frequency. Second column: Standard deviation of maximum position and value.

Figure 6 shows, for the second scenario (all the fans of the matrix are running except one), the mean (first row) and standard deviation (second row) values for the position coordinates (first and second columns) and the specific value (third column) of the maximum of the acoustic image obtained for the selected working frequencies. In this case, each coloured line matches with the corresponding faulty fan on the matrix.

In this Figure 6, first and second columns show that for the nine working situations the behaviour of mean values of the azimuth and elevation coordinates are similar for the different working frequencies. Despite this similar behaviour, each working situation can be distinguisable, because each line is centered on a differente mean value. In this scenario, the corresponding standard deviation figures show that for low working frequencies the standard deviation values are low (1.5°), but for working frequency values higher than 2400 Hz, the standard deviation values are high (until 11° and 9°), and it becomes higher with larger frequencies. This is the reason why the researchers decided not to use this estimator on the second scenario, for working frequency values higher than 4000 Hz.

In the third column of Figure 6, as in Figure 4, it can be observed that the maximum value decreases with the increasing frequency and that for all working situations, the maximum values are very similar (between 150 and 120dB). In this case, the standard deviation behaviours are similar for all the working situations of the matrix, except one that shows higher values. In this second scenario, the maximum value is not again a good parameter to be used to differentiate between the corresponding nine working situations.

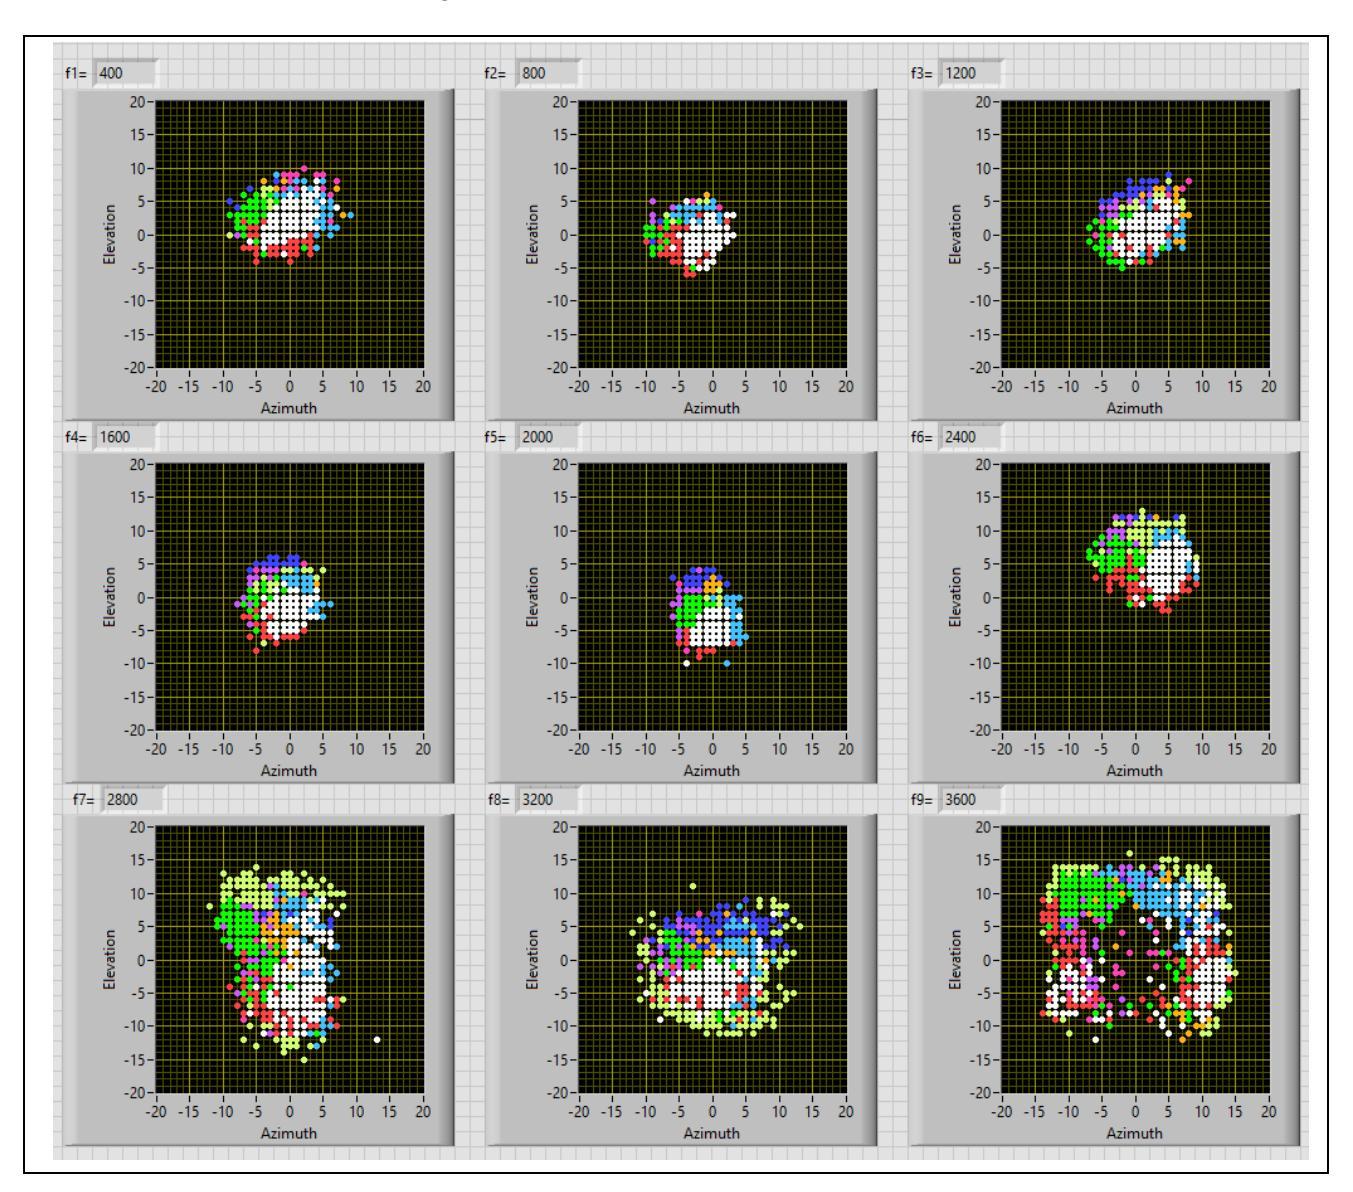
Figure 7. Maximum position dispersion vs. frequency for the second scenario (all the fans except one are running).

Figure 7 shows, for this second scenario, the maximum position dispersion for the different working frequencies. In this figure, each coloured point represents the maximum position of one of the 100 acoustic images obtained for each of the nine faulty fan situations.

In Figure 7, it can be observed that for all the frequencies, the maximum positions are mixed together for all the working situations, for all the faulty fans. It seems that for any frequency, the estimator could not be able to differentiate which fan is the faulty one in each situation.

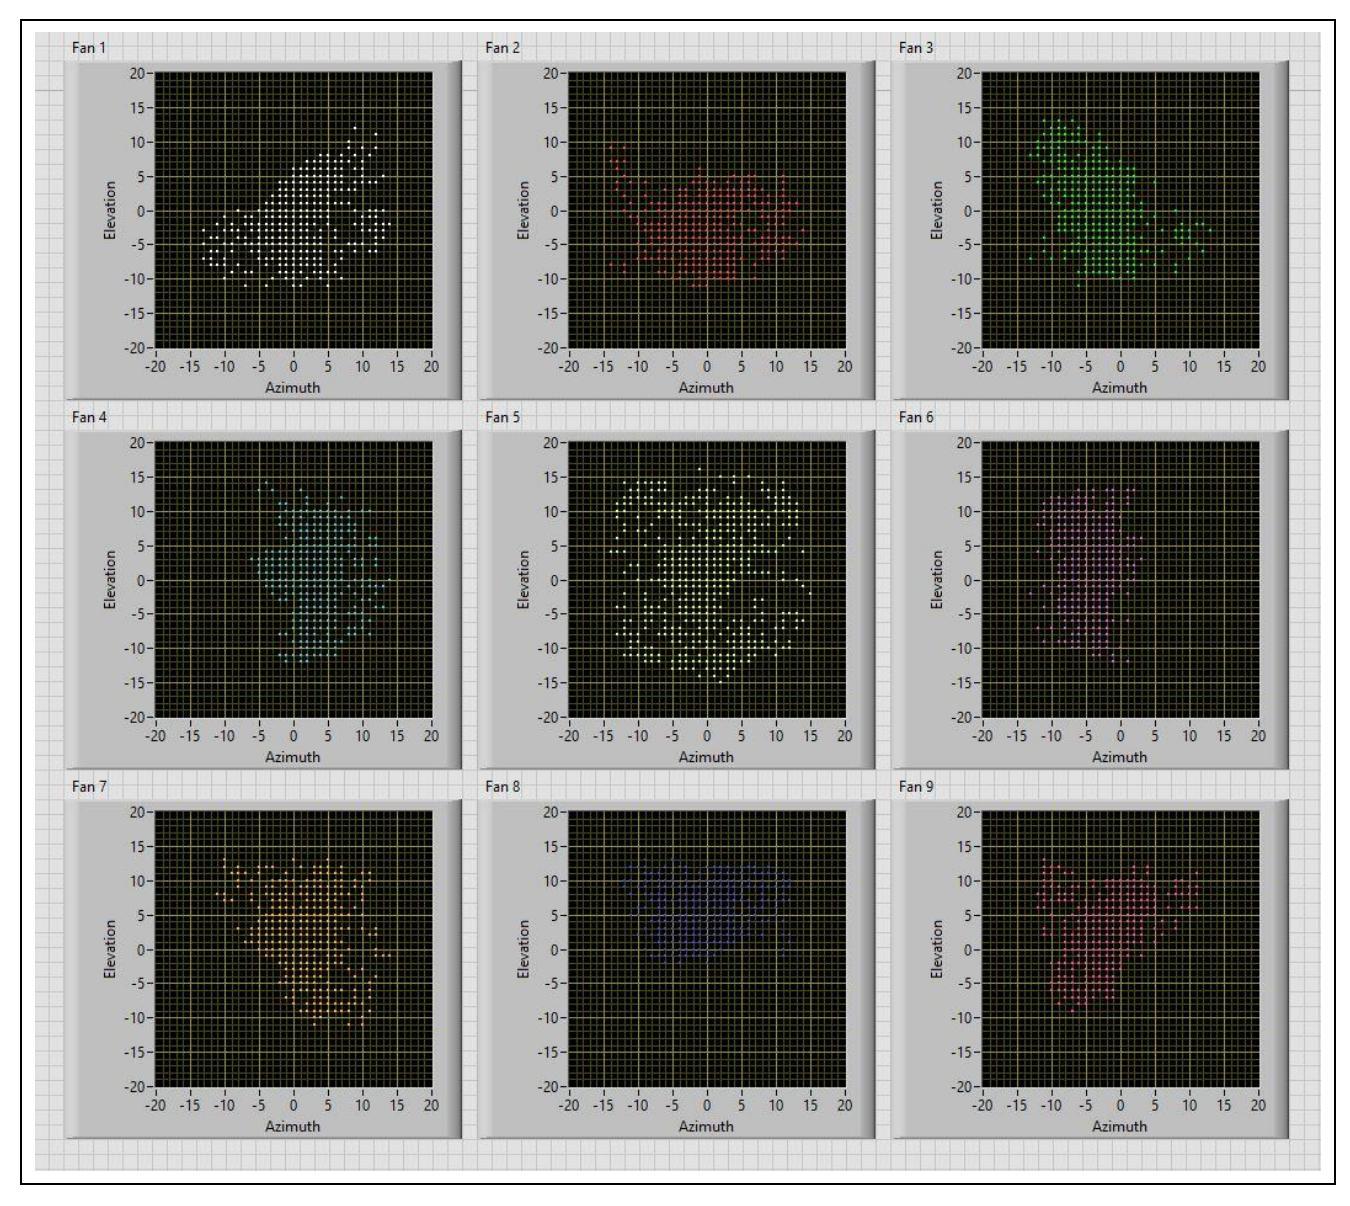
Figure 8. Maximum position dispersion vs. position of the faulty fan for the second scenario (all the fans except one are running).

Figure 8 shows, for this second scenario, the maximum position dispersion, in this case for each faulty fan situation. In this case, it can be observed that the positions of the maxima move to the opposite direction to the faulty fan position. The dispersion behaviour is different for each faulty fan situation. This fact makes the estimator reliable to be used to differentiate the working situations.
